THALASSA - Renewal survey - 2025

Renewal survey

Ship name	THALASSA
IMO	9070307
Ship type	Fishing Support Vessel
Flag	France

1.2 Renewal of RV *Thalassa*

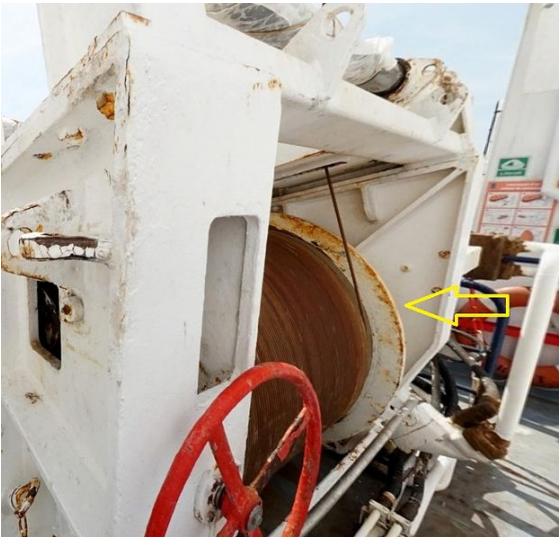
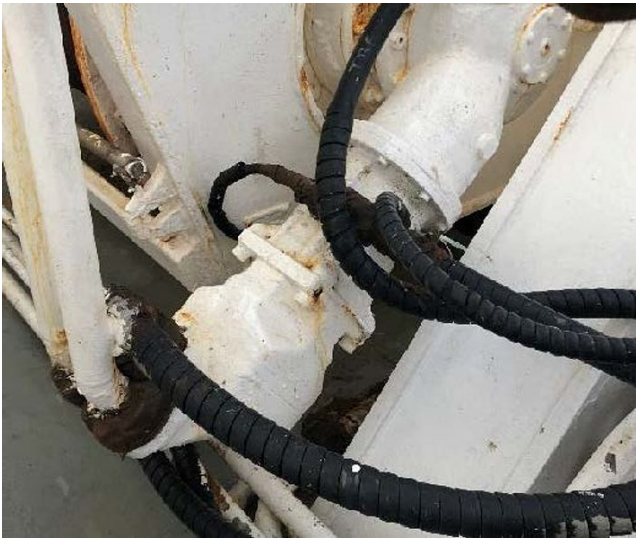
1 -42 P			
Single conductor armored cable, designed and specially manufactured for use in well logging. The armor wires are high tensile, galvanized improved plain steel, performed and prestressed. The armor could be coated with an anti corrosion compound.

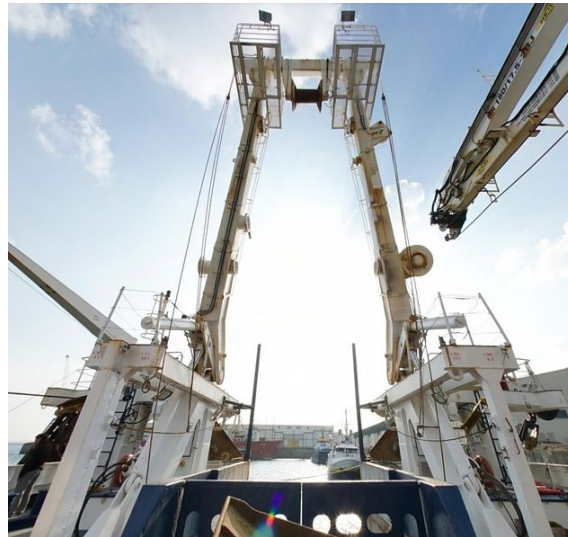
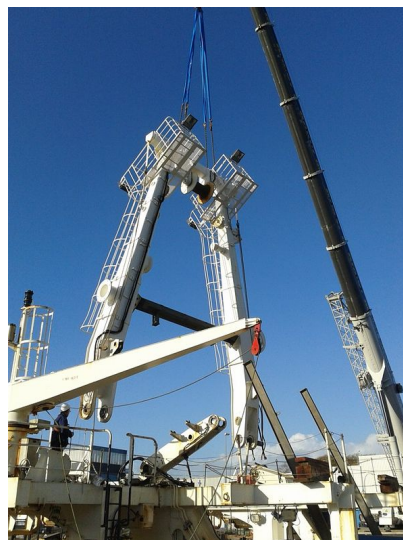
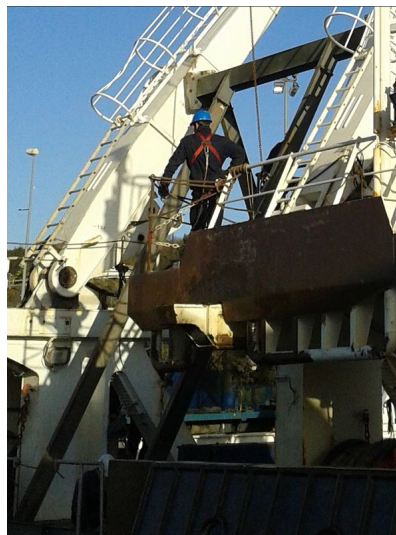
- Vérin seconde extension : 200 x 85 x 2075
- Vérin première extension : 200 x 90 x 1940.

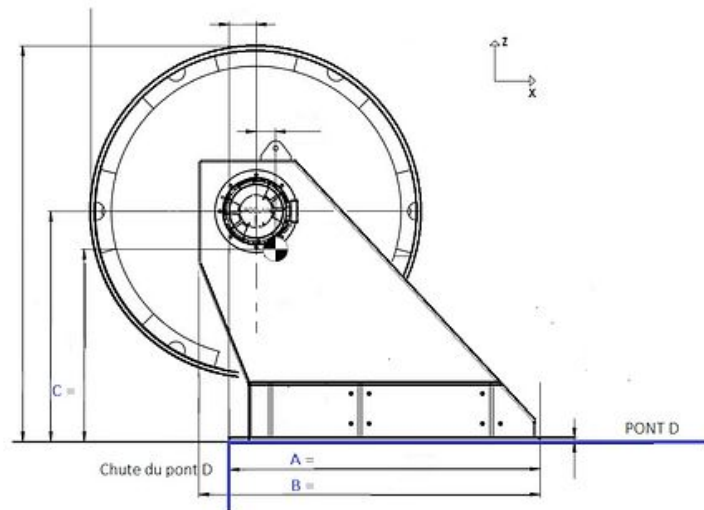
DNO-STN A.Samzun
Projet Enrouleur double à chaise décalée
N/O THALASSA

- Soit l'installation du nouvel enrouleur est décalée de la distance nécessaire vers l'arrière du navire.
- Soit le berceau du nouvel enrouleur est construit en diagonal pour assurer la chute directe de l'engin de pêche sur le pont C.

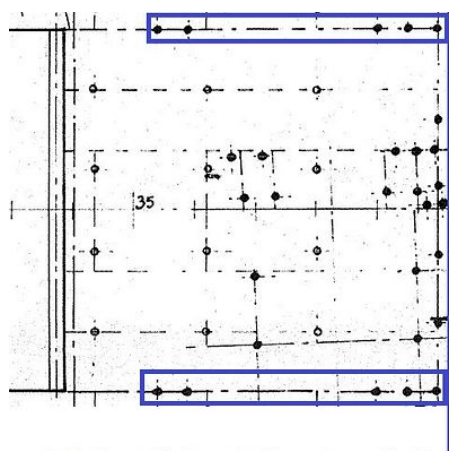
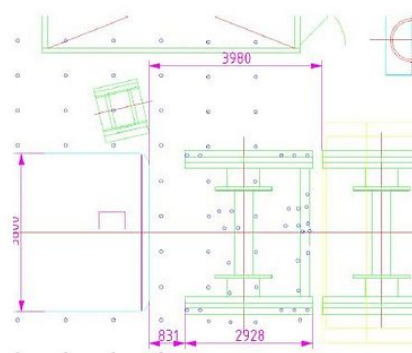
Fontaines utilisées actuellement pour fixation enrouleur pélagique pont D

D'après le plan AC 9-8 Leroux et Lotz Implantation des fontaines Pont C, D, E. Pour les détails fontaines plan partiel

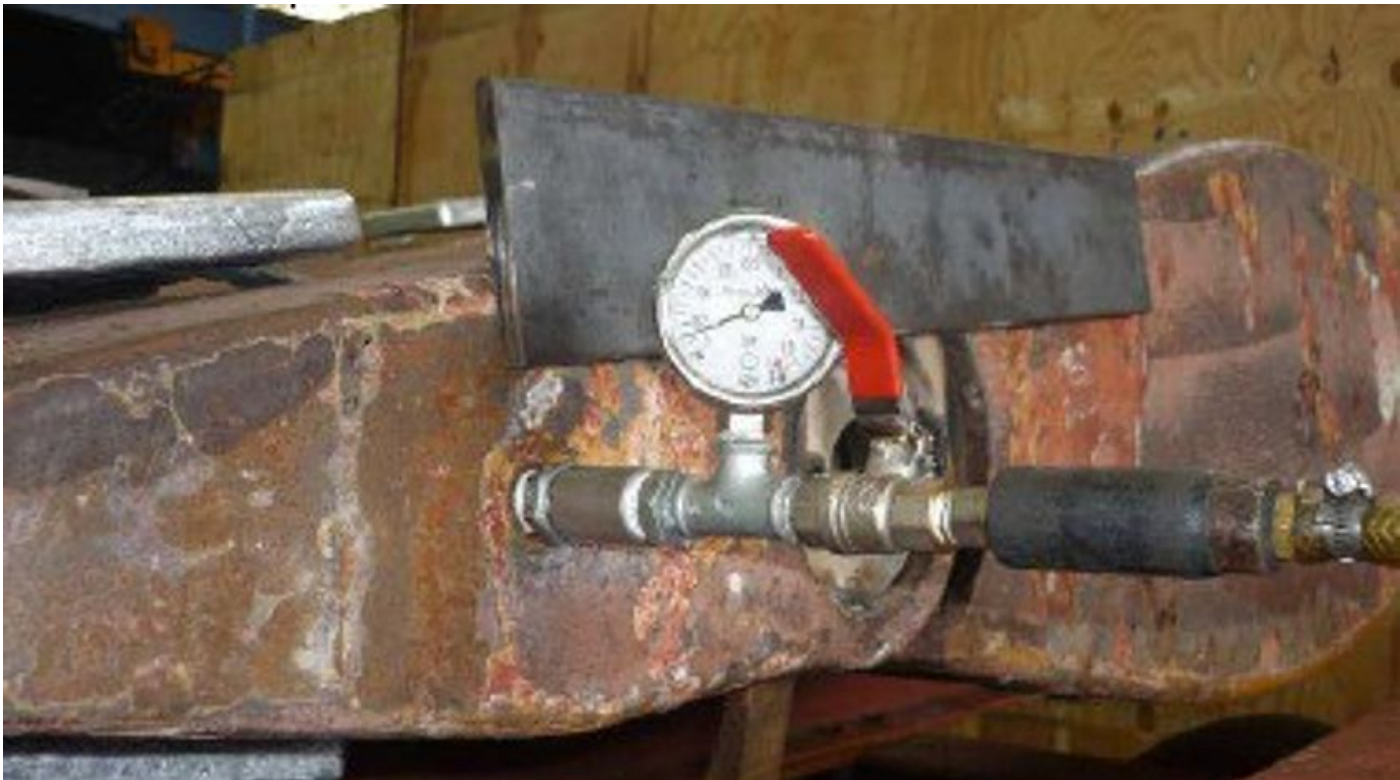
Description:
150 gram rudder leakage test

Name	Description	Quote type	Quantity
rudder leak test		Per unit	1.0

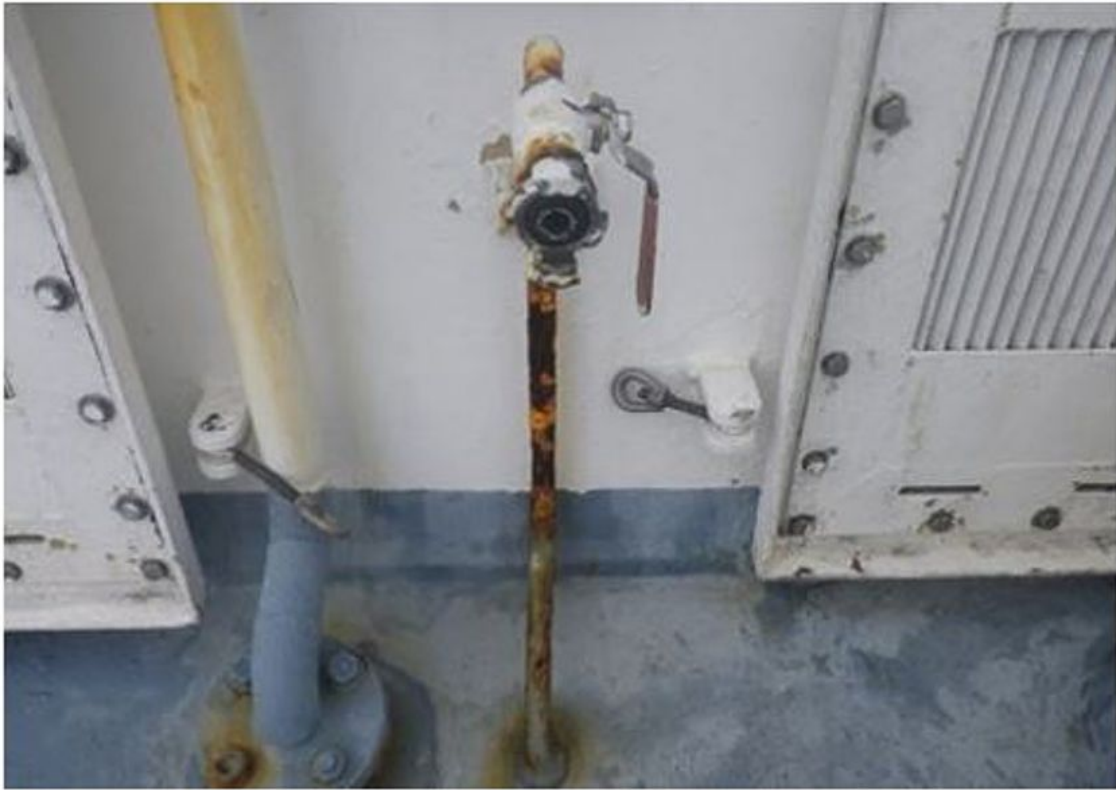
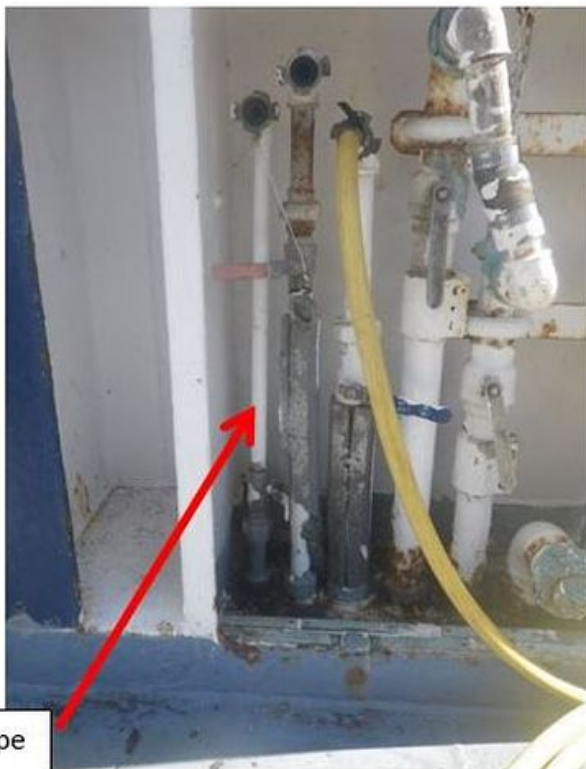
Air pipe

- Consign the pipe section
- Remove the extractor fan of the fish room and the siding behind it, upper and lower part
- Cut the old pipe, remove the sealing deck and take off the pipe
- Replacement of the passage-deck by a steel passage ext diam 20mm, int diam 12 mm, length: 100mm.
- Weld the new identical steel pipe
- Put a new valve and a pneumatic fitting as it was
- Replace the clamps
- The crew will check the absence of leaks before the reassembling of the lining's fish room by the shipyard

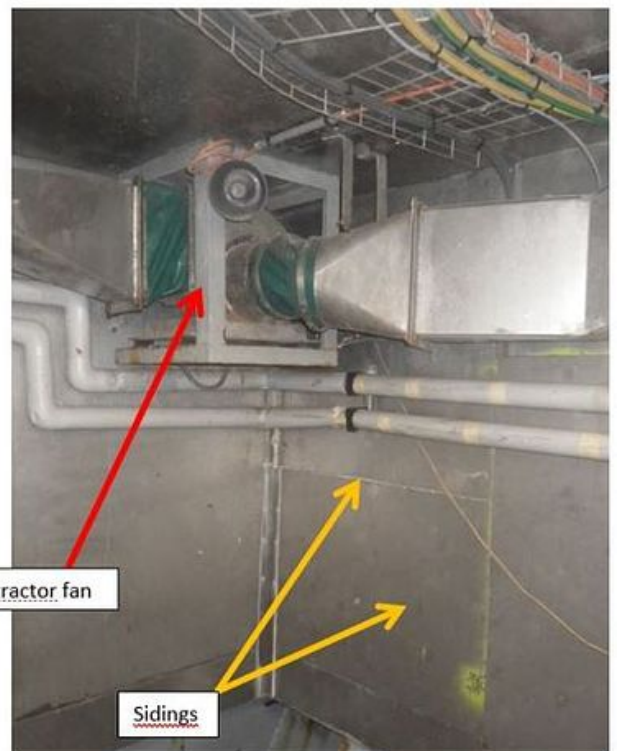
Extractor fan

Sidings

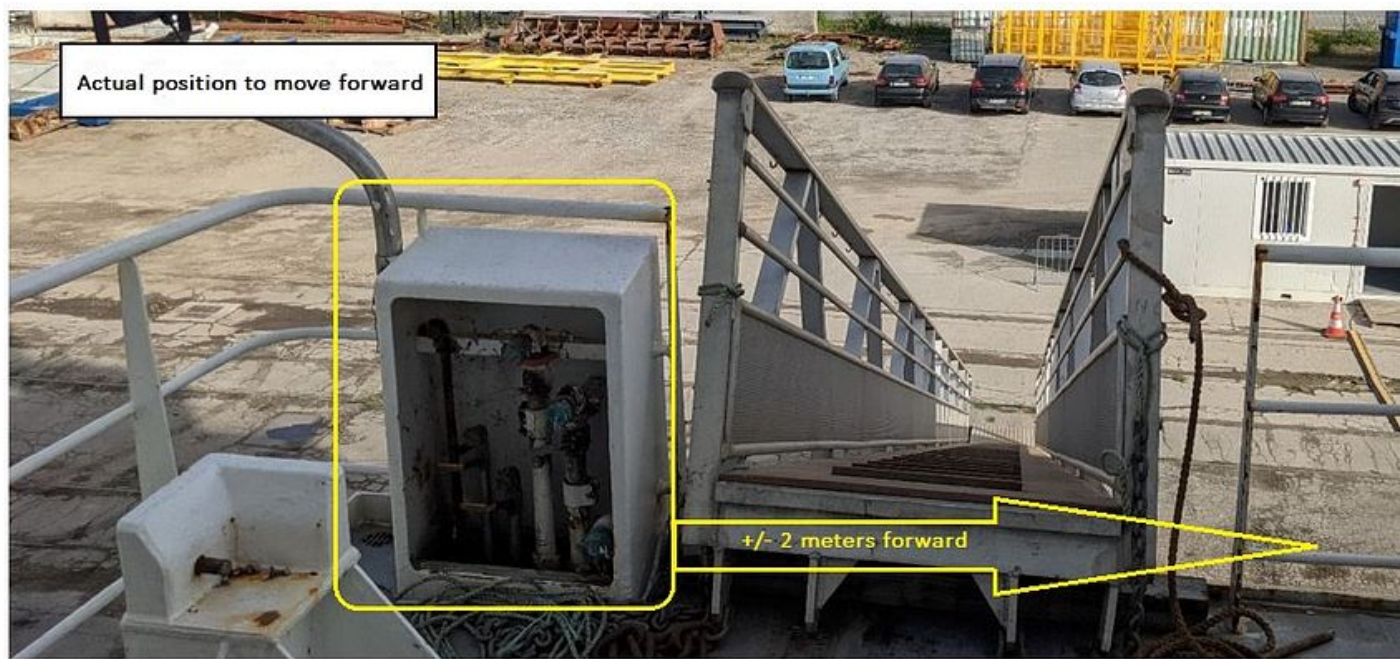
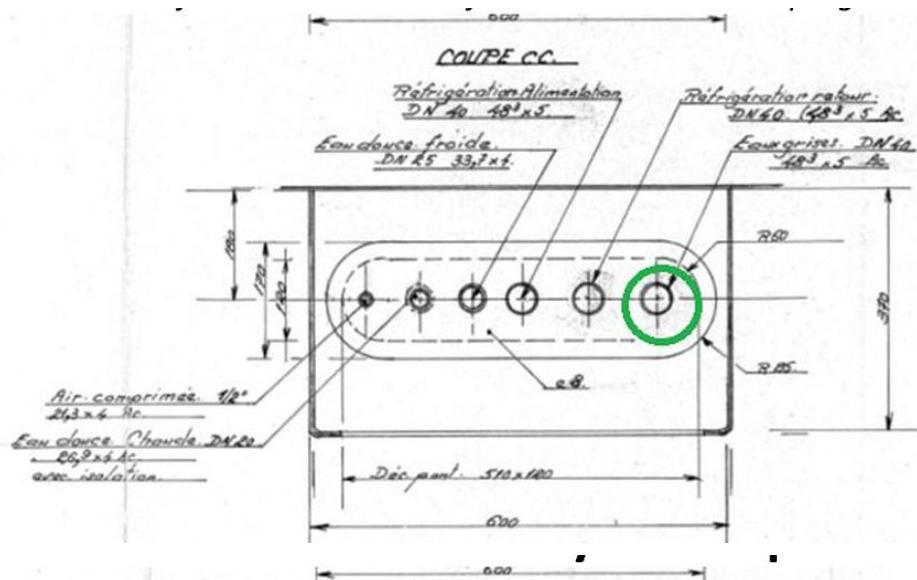
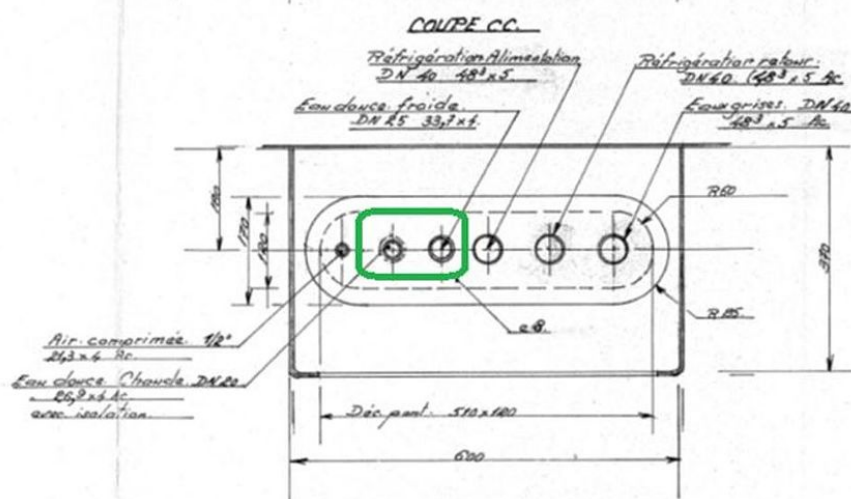
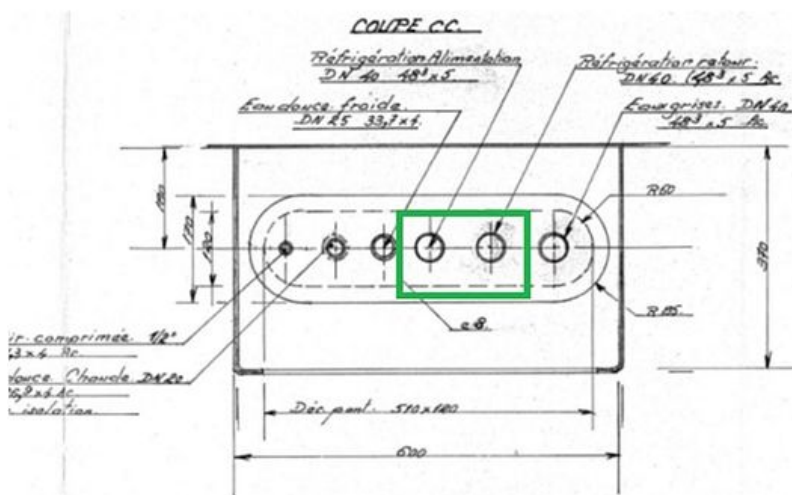
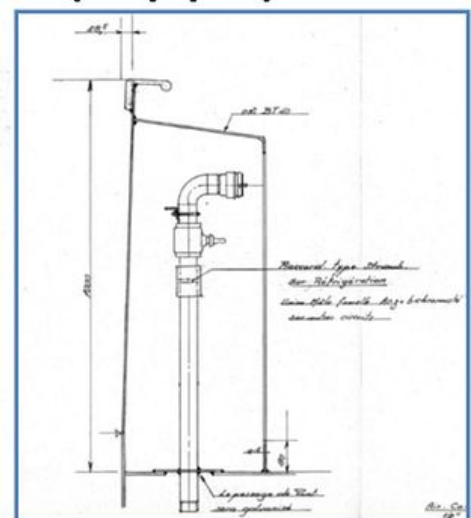
C.003_water piping for external container supply stations on deckC.003

In green the location of the feed stations

Replacement of the deck passages and the warm (DN20) and cold (DN25) water pipework with valves and fittings.

For each feed station (5), replacement of the two DN40 seawater pipes (supply/return) containers up to the straub coupling and repair of the deck passages:

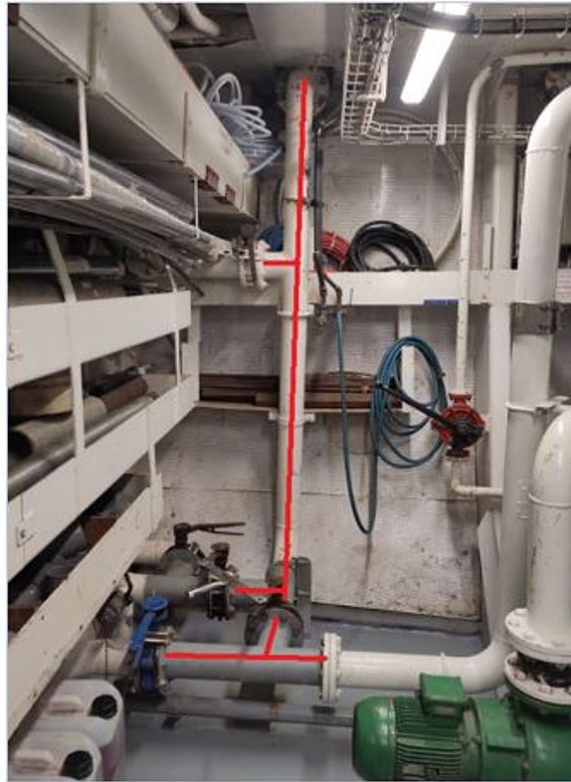
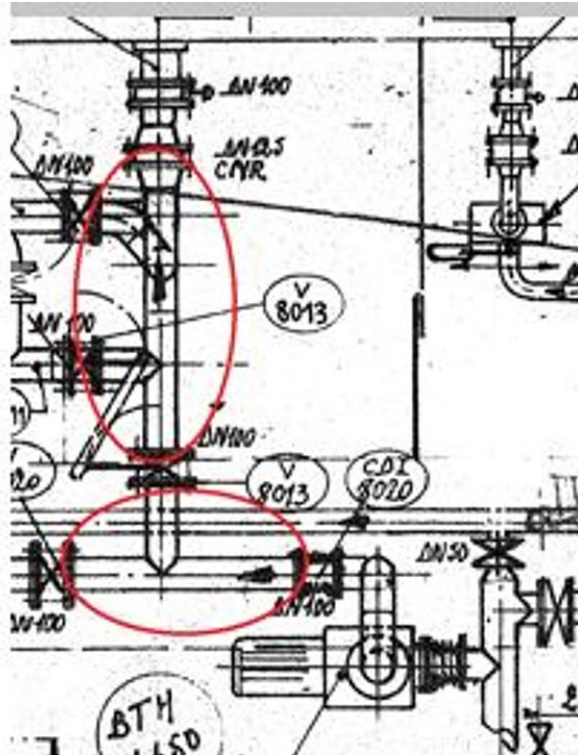
Replacement of the 2 sections of pipework marked in red in the appendices below.

Name	Description	Quote type	Quantity
Black water discharge replacement		Per unit	1.0

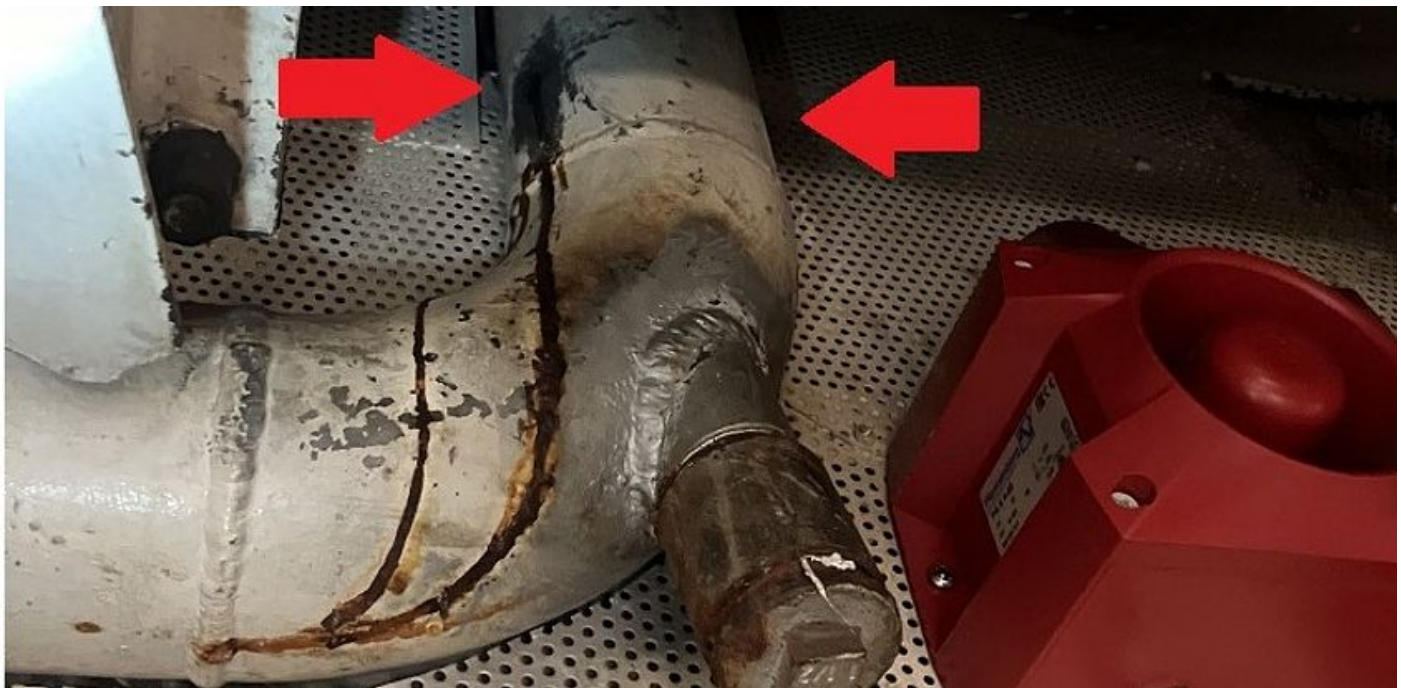
Name	Description	Quote type	Quantity
Drain strainer pipe replacement		Per unit	1.0

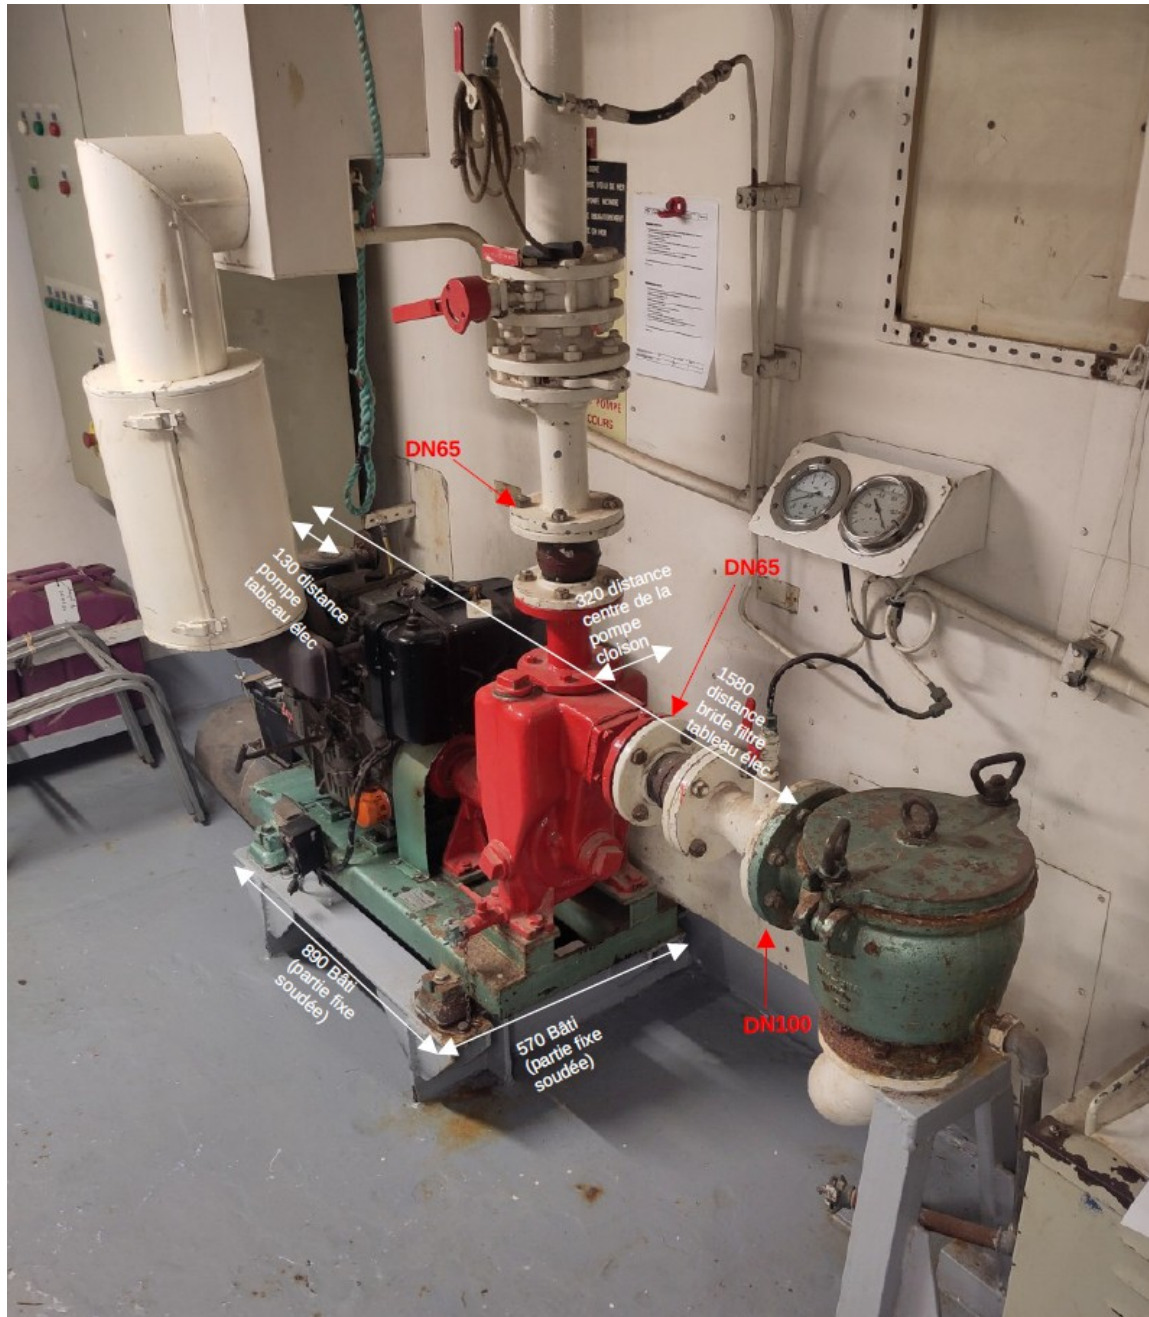
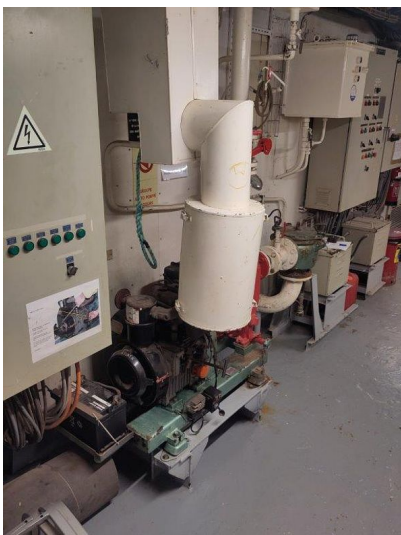
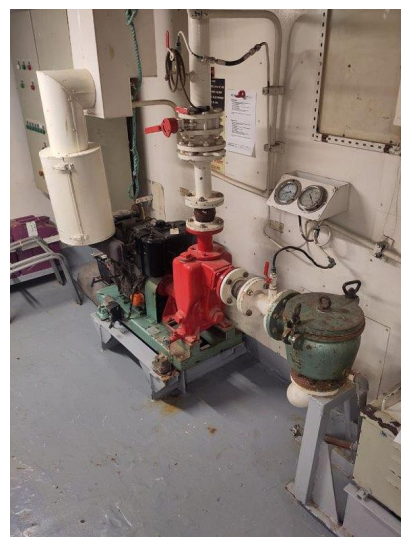
Description:
OPTION 1: Identical repair based on the attached picture
OPTION 2: Proposal to replace only the folded parts
Stainless steel tube, total 3940 linear mm, diameter 60

Name	Description	Quote type	Quantity
OPTION 1: Identical repair based on the attached photo		Per unit	1.0
OPTION 2: Proposal to replace only the folded parts		Per unit	1.0

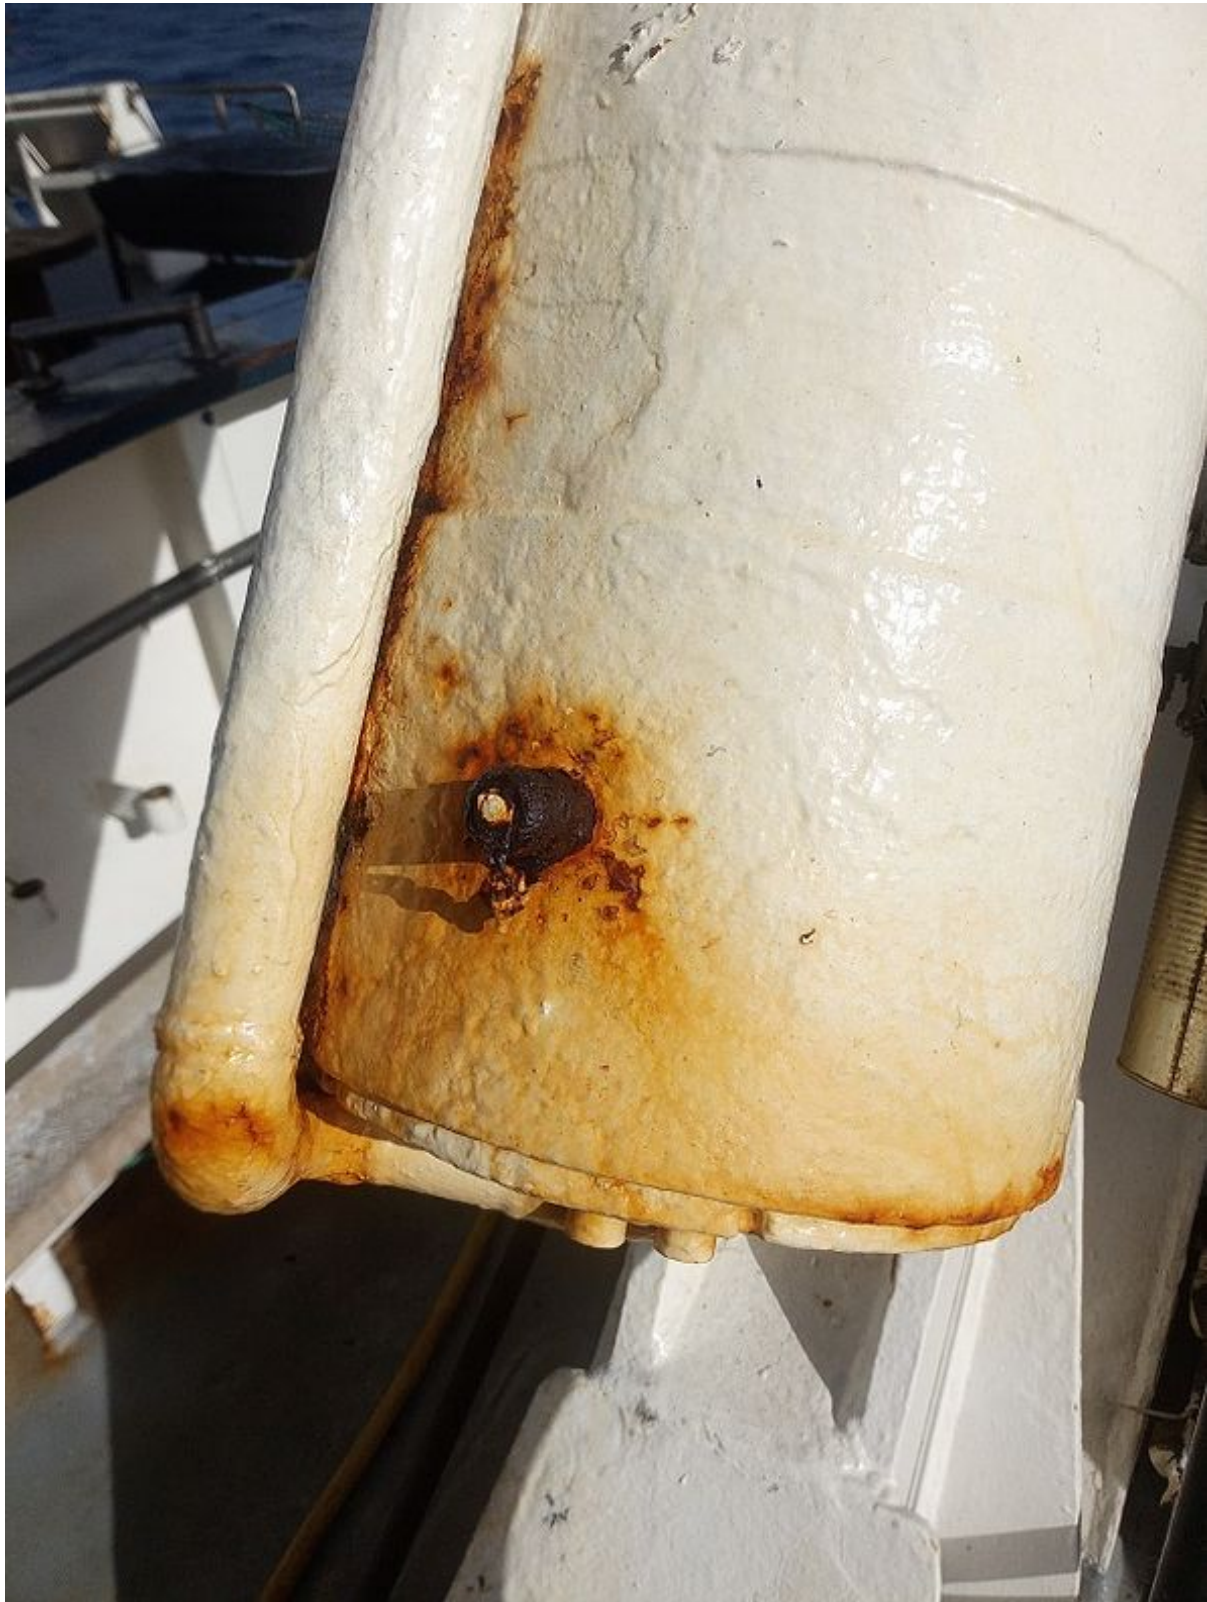
D.005_ Hatches on starboard c & b deck_Access to Engine Room D.005

Name	Description	Quote type	Quantity
Protection_access_cleaning		Per unit	2.0
Watertight hatches repair		Per unit	2.0

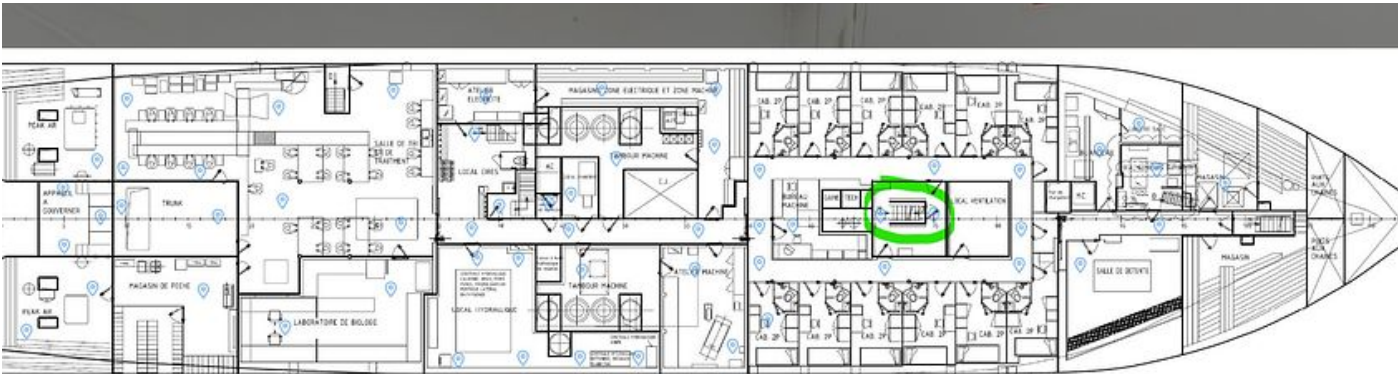
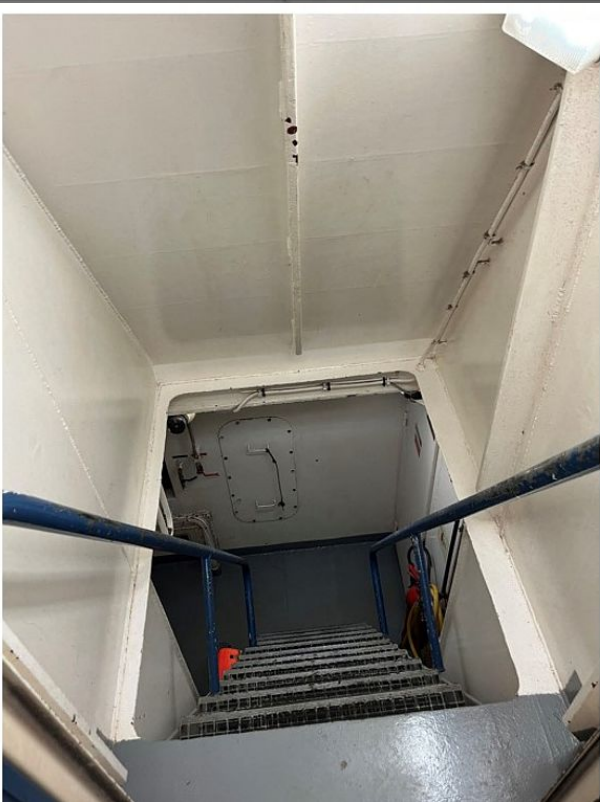
Name	Description	Quote type	Quantity
Protection_access_cleaning		Per unit	1.0
Welding of a 500 kg SWL lifting ring		Per unit	1.0
NDT		Per unit	1.0

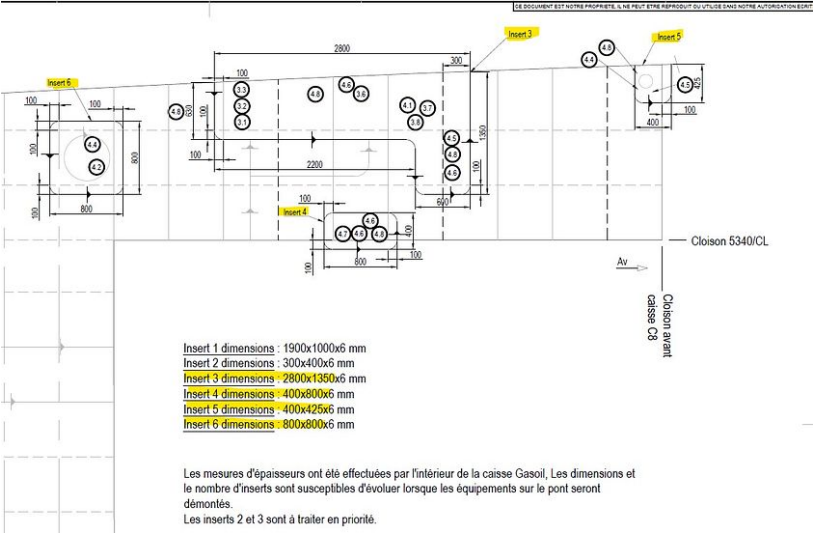
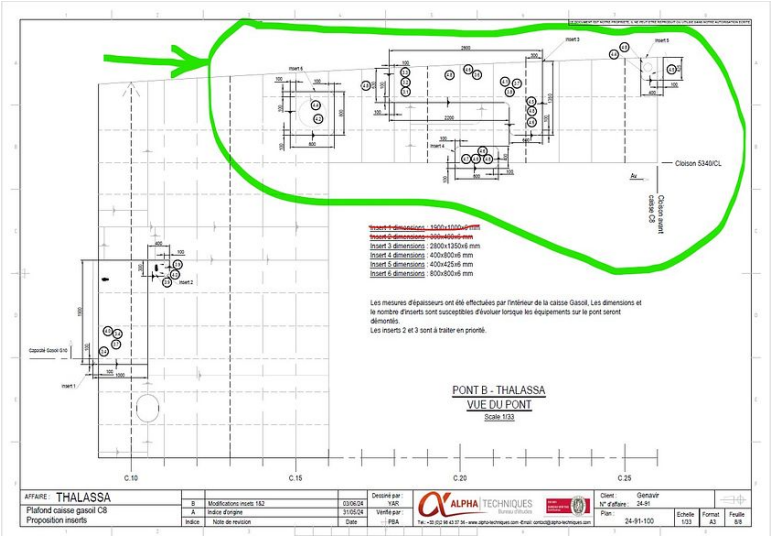
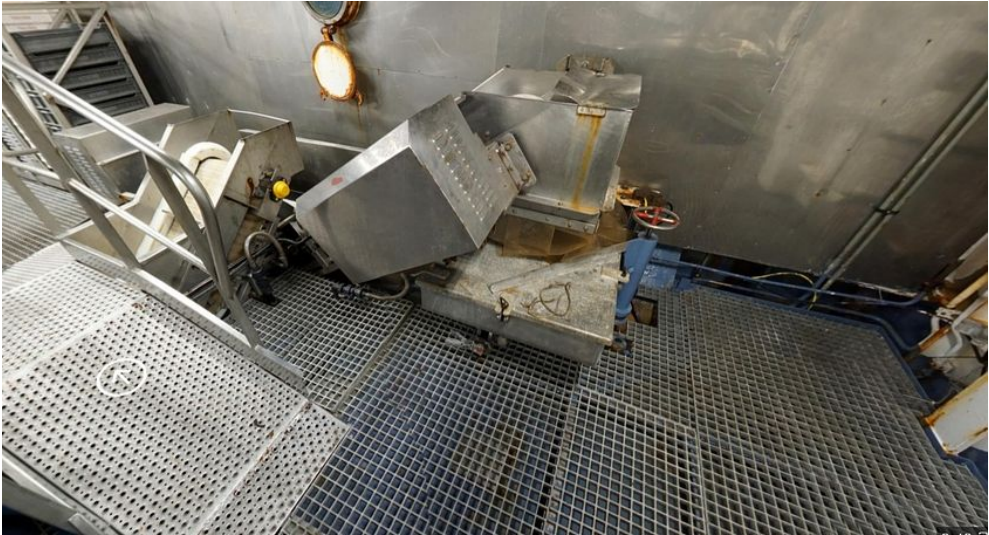
Repairs of C8 DO tank top plate to be performed iwo port side shell from fr 15 to frame 26, see alpha technique UTM company report n° 24-91-100 for more details

Following thickness measurements carried out in May 2024, repairs are required to the ballast ceiling of the C8 fuel tank. The ship repair yard must quote for this ITEM:

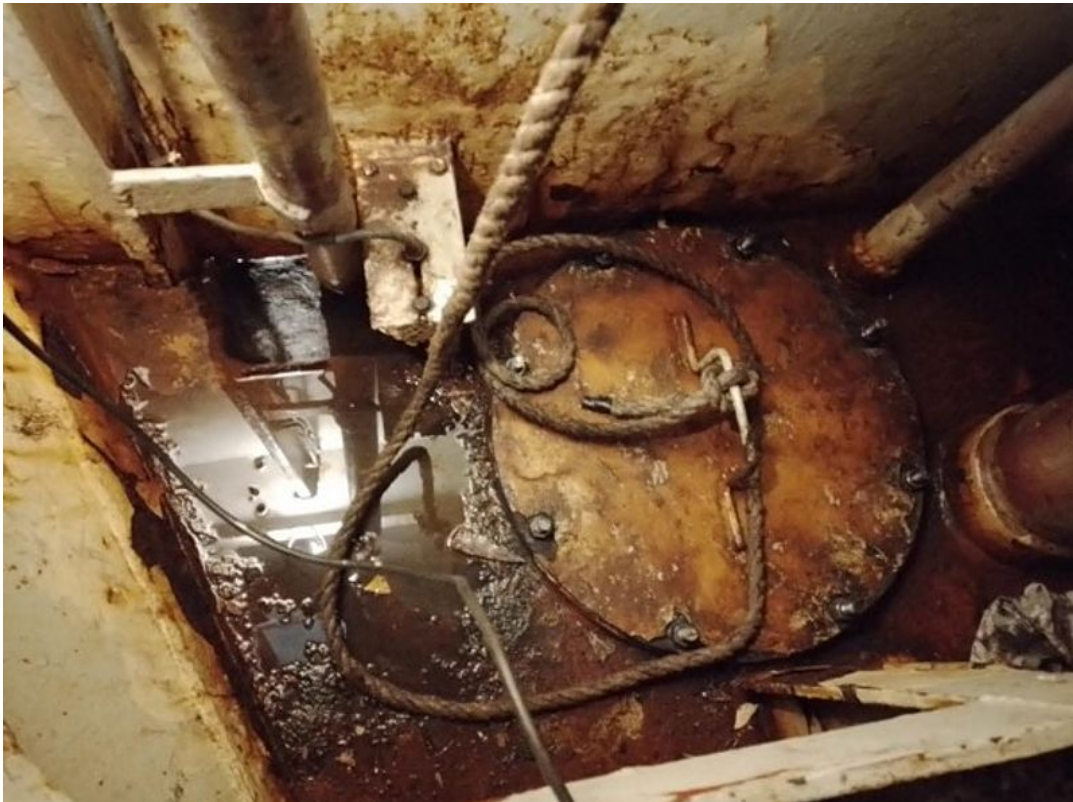
Plafond de ballast EM1

The surface of the ballast top plate at the bottom of the dry mesh is completely corroded, as is the crown supporting the manhole hatch (damaged threads). There is water coming from the chain well, which is regularly drained.

- Repairs to the entire surface, adjoining partitions and hatch.
- Pitting, sanding.
- Making the necessary inserts
- Replacement of the crown of the manhole.
- Painting system. see item f.016

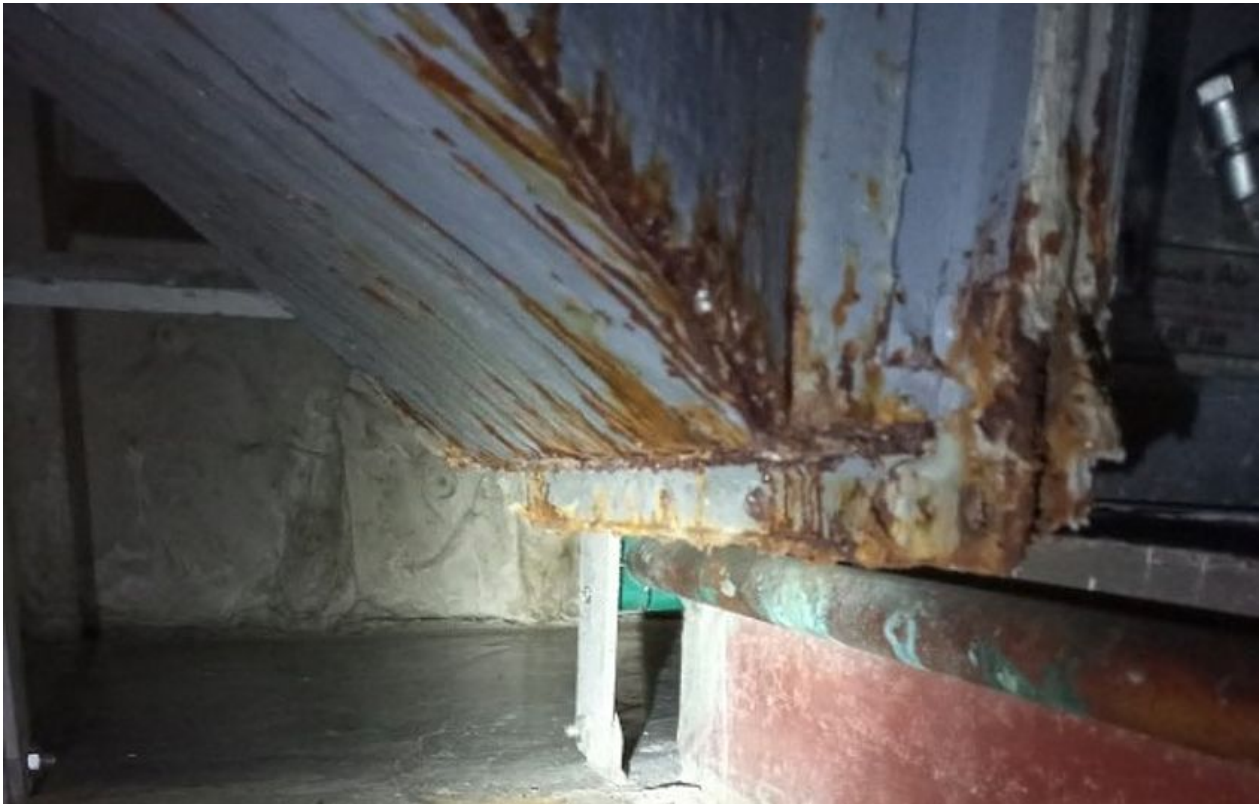
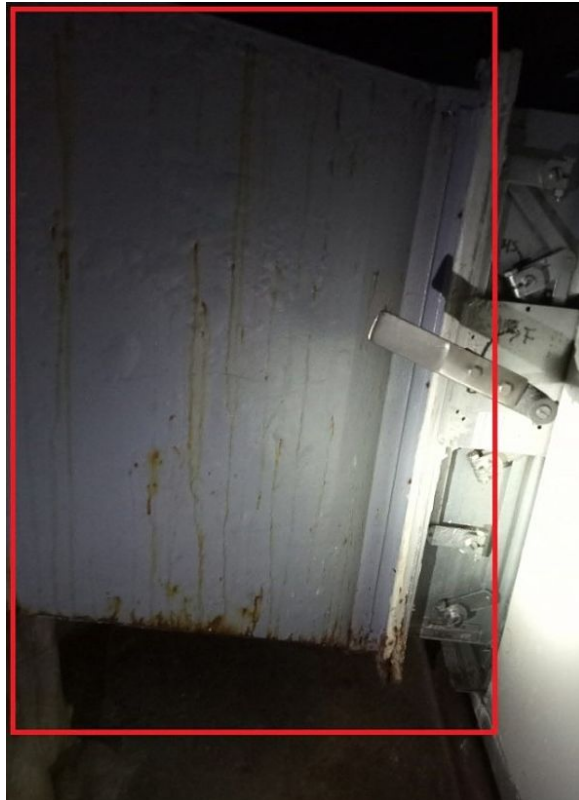
- Removal of the corroded duct.
- Renew of the steel duct with protection against oxidation (galva) .
- Dimension are 300 x 500 mm (small side) to 500 x 500 mm (large side)
- Steel plate of 4 mm
- Reassembly with insulation between the aluminium walkway structure and the duct to prevent galvanic corrosion.
- Installation of a new register (supplied by GENAVIR).

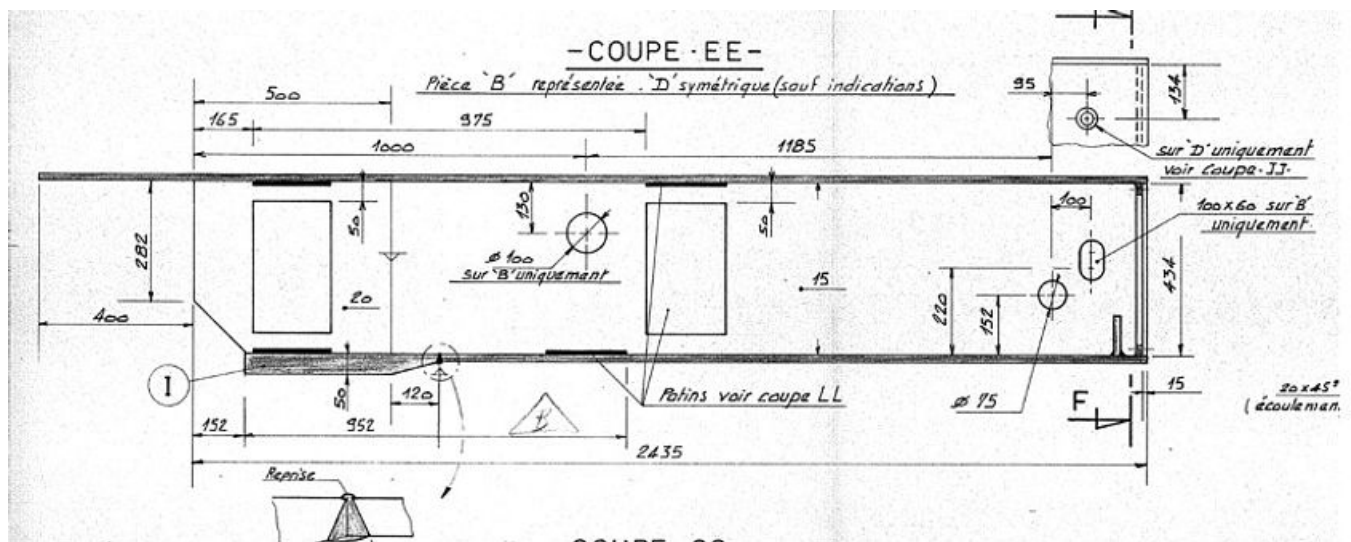
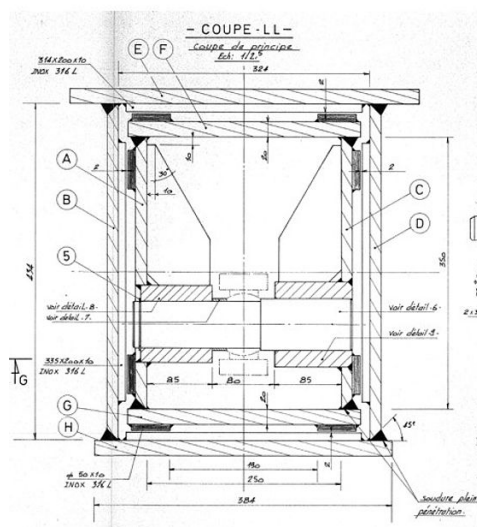
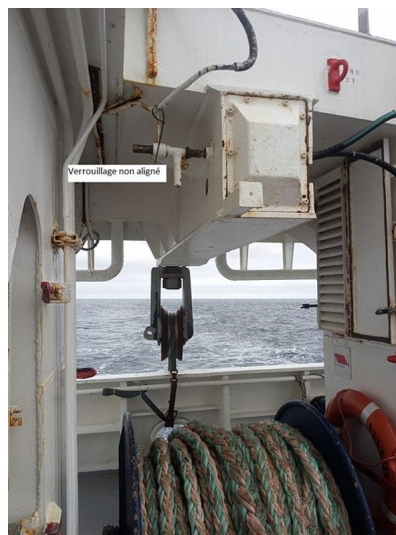
- Remove the outrigger jacks
- Check the dimensions of the stainless steel runners and replace them.
- 316L stainless steel horizontal shoes (314x200x10mm)
- 316L stainless steel vertical skids (335x200x10mm)
- Cleaning and painting of the rectangular boxes and the Bd and Td brackets and check the condition of the guides will be done by crew as per international specifications
- Re-installation of all these elements once refurbished.

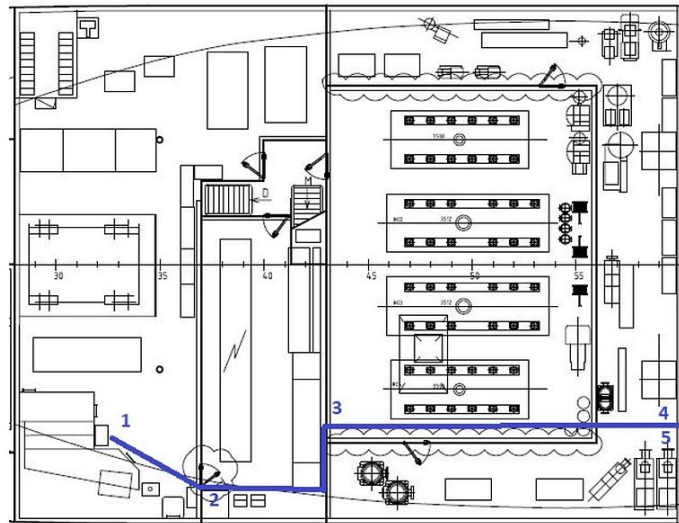
E.001 – 24V CATERPILLAR SENSORS SUPPLY MODIFICATION

According to new electrical drawings conducted by Barillec in summer 2023

- Removal of the 24V battery and charger
- Run an electrical cable from the 220V regulated switchboard to under the parquet flooring in the generator room. Length to be provided +/- 25m
- Replacement by a 230v regulated / 24V power supply in the motor panels.
- Use of 230/24V regulated and 24V AUT as back-up.
- Addition of an automatic circuit selector (diode or other) which switches automatically if there is a lack of voltage when one of the power sources is lost.
- Addition of a 24V Permanent Insulation monitor

- Removal of the 24V battery and charger
- Lay an electrical cable from the 220V regulated switchboard to under the parquet flooring in the generator room. Length to be provided +/- 25m
- Replacement by a 230v regulated / 24V power supply in the motor panels.
- Use of 230/24V regulated and 24V AUT as back-up.
- Addition of an automatic circuit selector (diode or other) which switches automatically if there is a lack of voltage when one of the power sources is lost.
- Addition of a 24V Permanent Insulation monitor

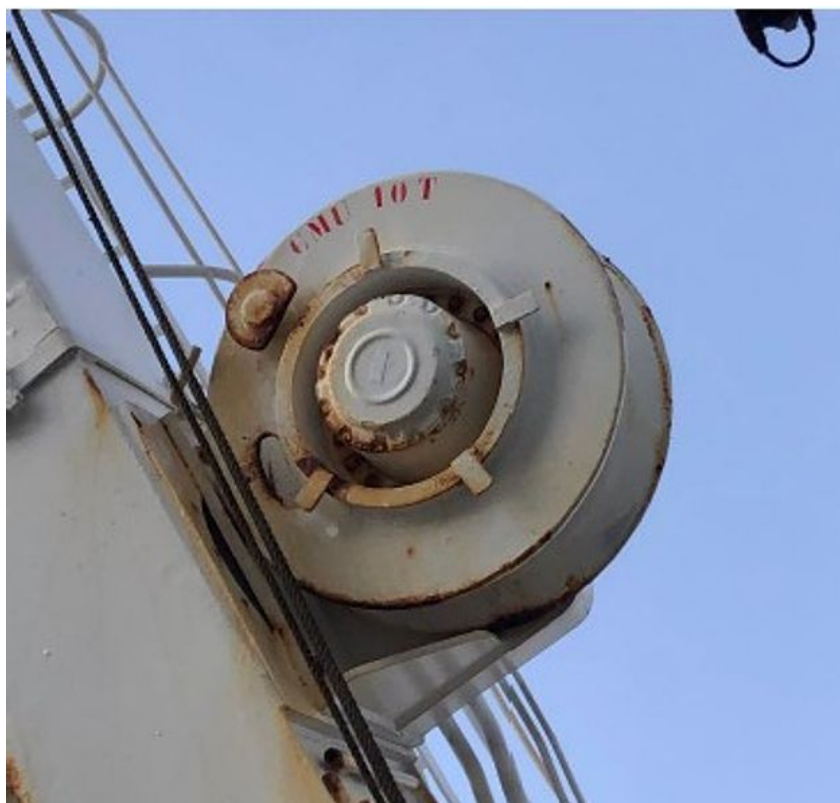
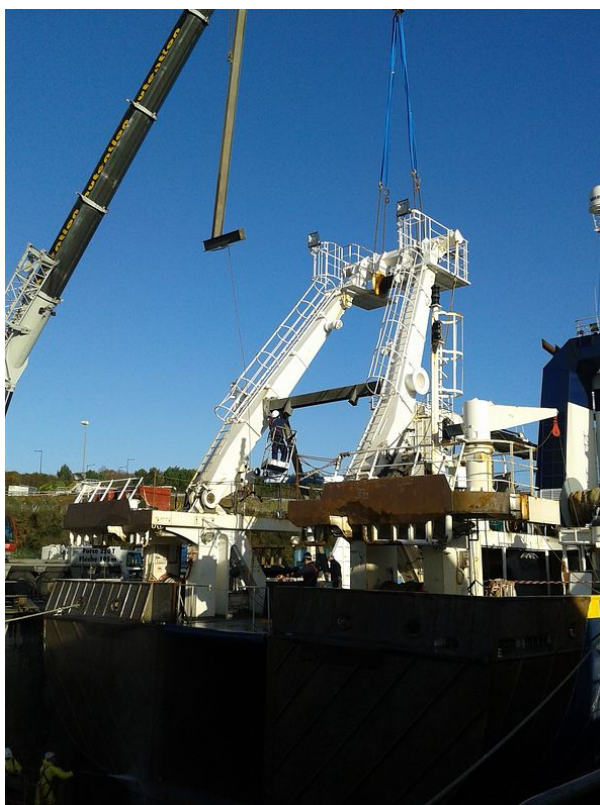
Name	Description	Quote type	Quantity
Side winch CMU 10T painting job		Per unit	1.0
A-frame without fittings and after repair painting job		Per unit	1.0
