THALASSA - Renewal survey - 2025

Renewal survey

Ship name	THALASSA
IMO	9070307
Ship type	Fishing Support Vessel
Flag	France

1.2 Renewal of RV *Thalassa*

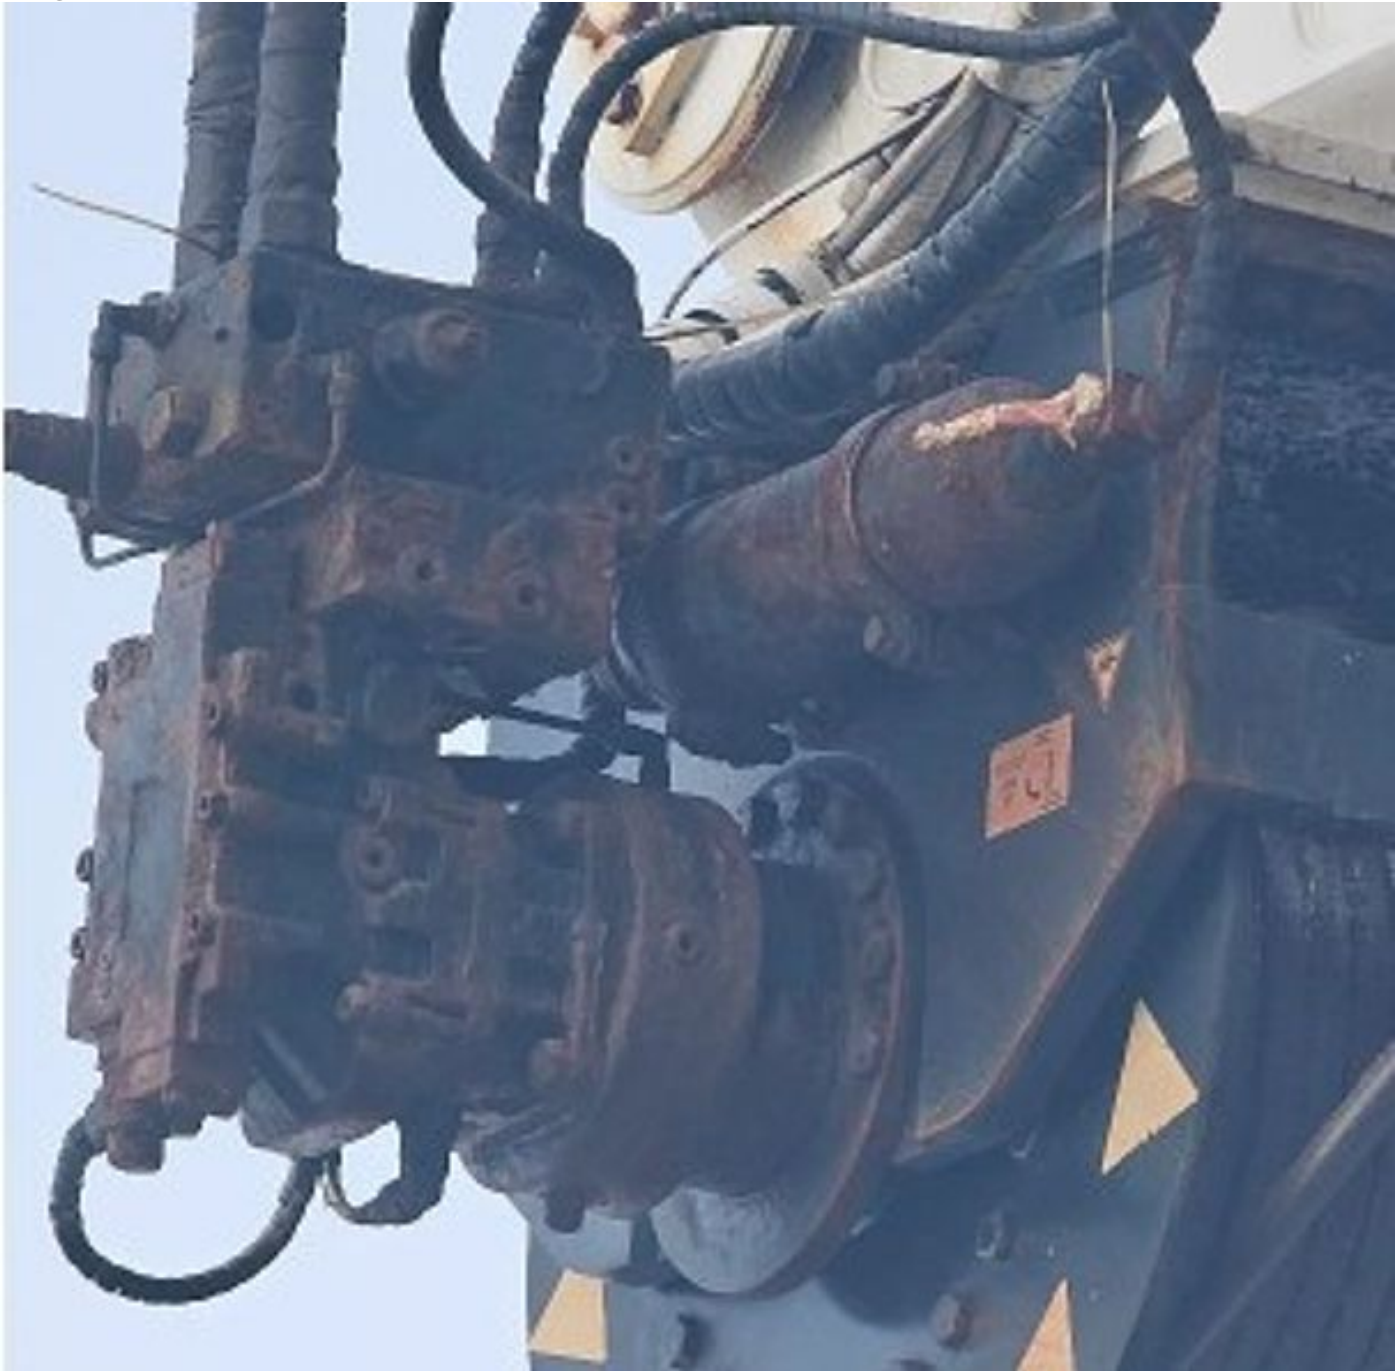
Name	Description	Quote type	Quantity
Both winch painting job		Per unit	2.0

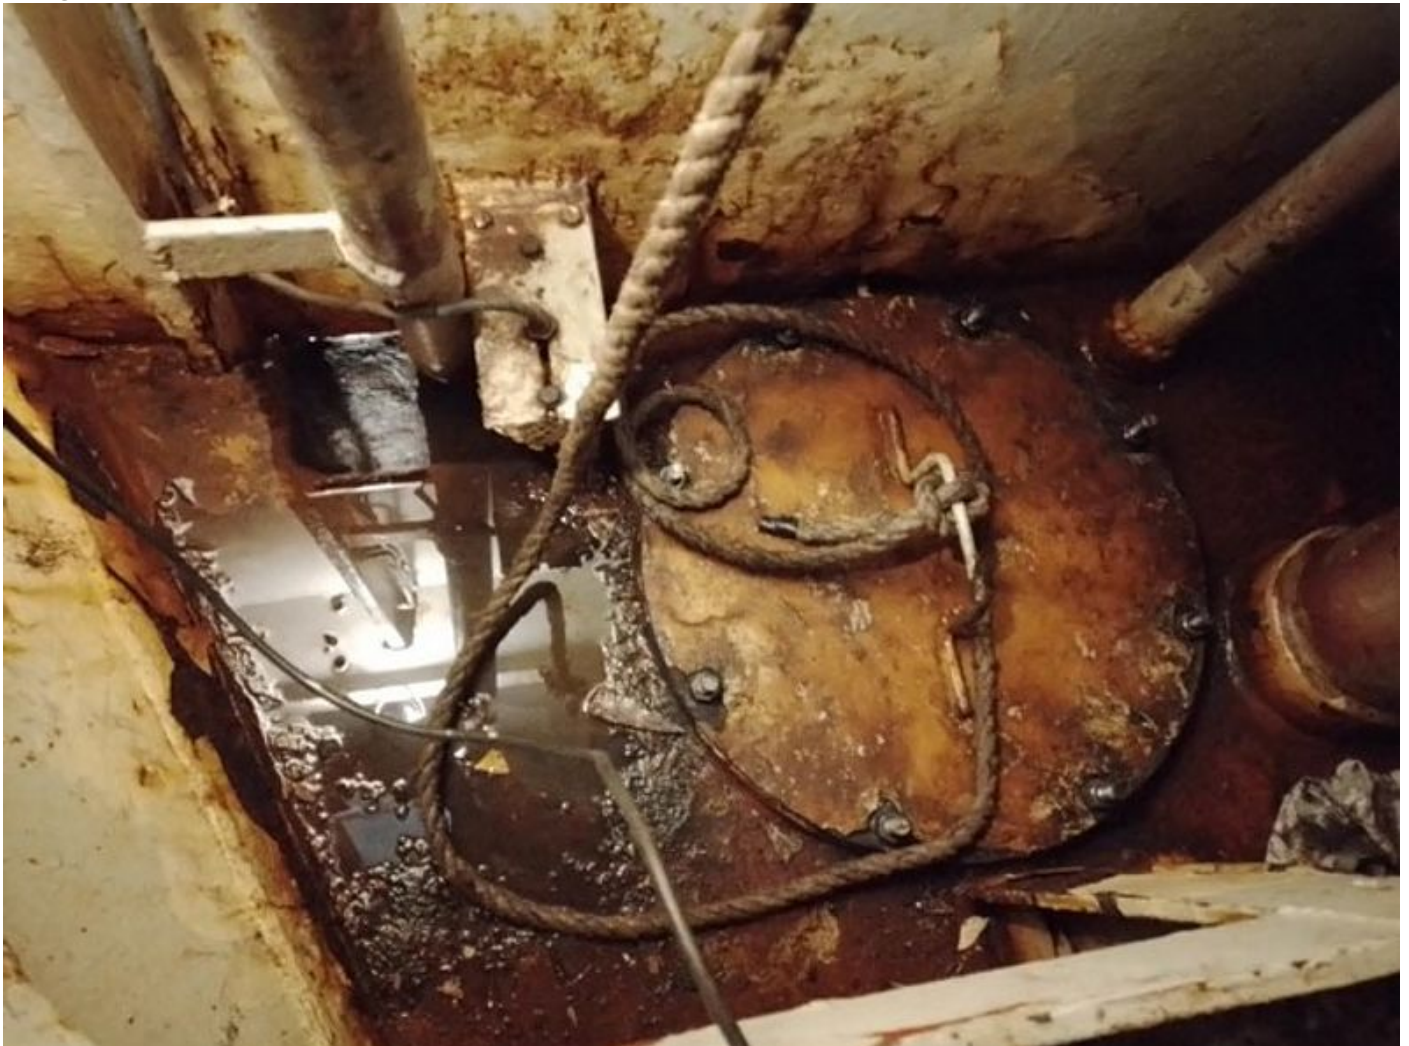
Name	Description	Quote type	Quantity
Sea Water ballast n°1 access & Top painting		Per unit	1.0

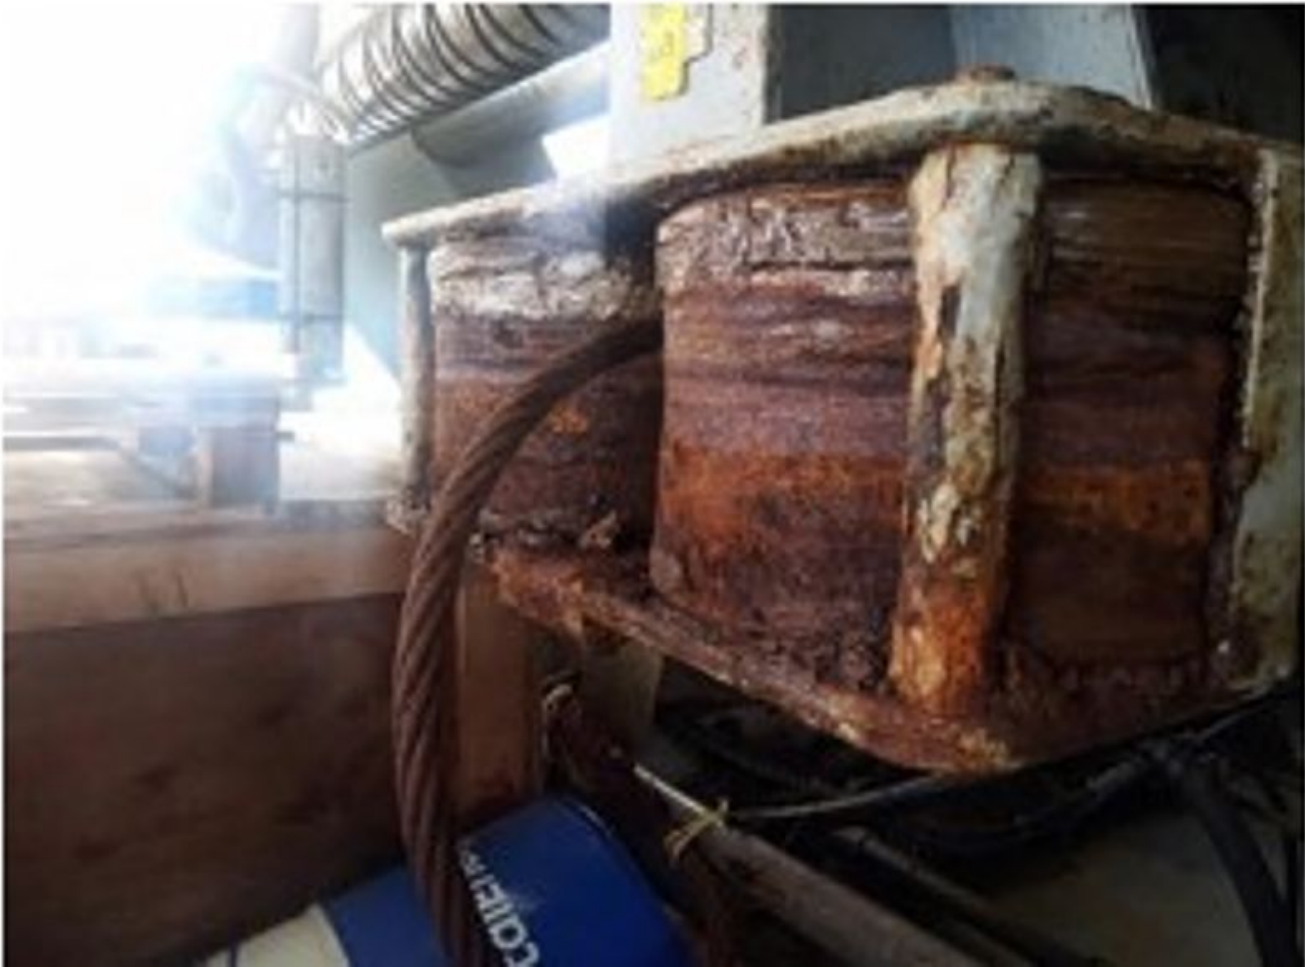
- Complete dismantling
- sandblasting
- rebuilding of metal rollers
- Replace steel if needed in supports
- paint treatment as per international specifications

Name	Description	Quote type	Quantity
Fishing winch rollers painting job		Per unit	2.0
Fishing winch rollers reloading of steel		Per unit	4.0
