# CHALLENGER 11

## Mid-life refurbishment

### Technical specifications (CCTP)

*Anthony VENDE - 03/10/2025 – Version 04*

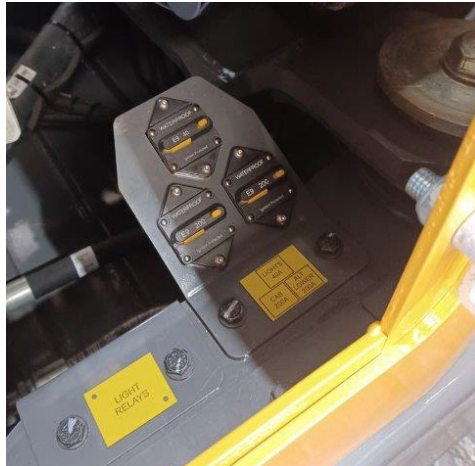
Relocate breakers near a side door like picture

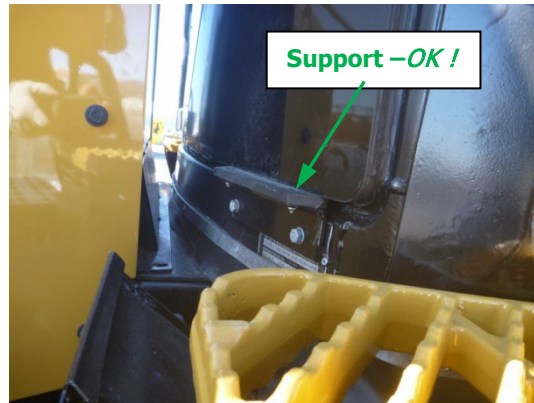
2) Fit retainer/plate under the windscreen, to hold windscreen during sticking operation on the field. The support has to maintain all the weight of the glass during sticking operation, as we cannot move the cab on a side to have the glass maintained by its weight. Support should be removable, so we can dismount it when we use the tractor.

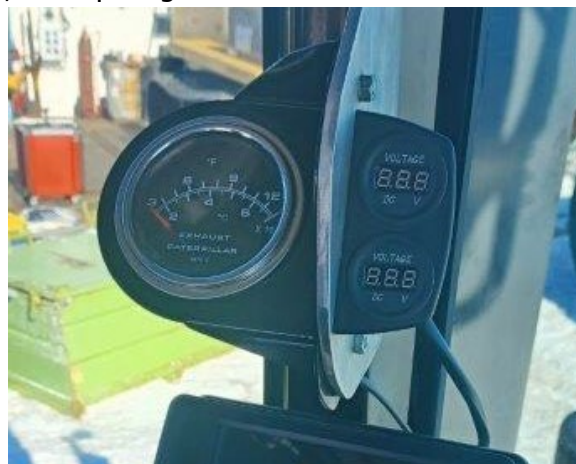
1) 12V indicators.

Fit one for each alternator, to help diagnosis in case of failure.

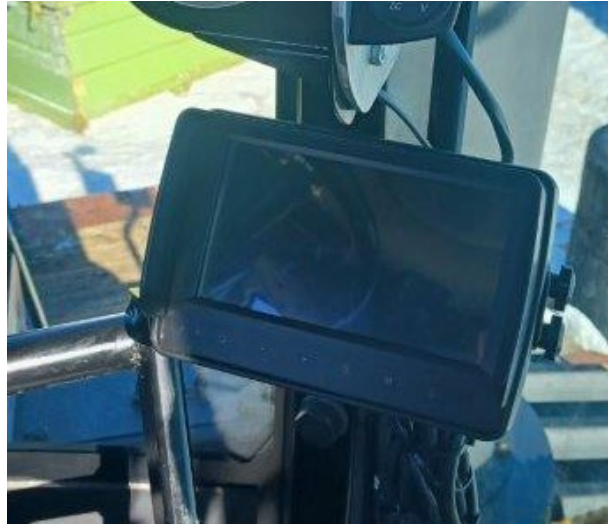
2) Rear camera.

Install a rear camera that gives view on the towing hook. It have to be fitted on the gearbox with a dedicated support. Add a screen dedicated in the cabin.

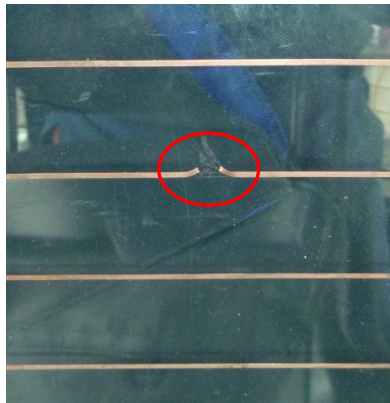
3) Fit a window heater on the rear window to avoid icing.

Be mindful that the headrest should not damage the wiring (see picture). Seat and/or headrest movement has to be restricted accordingly.

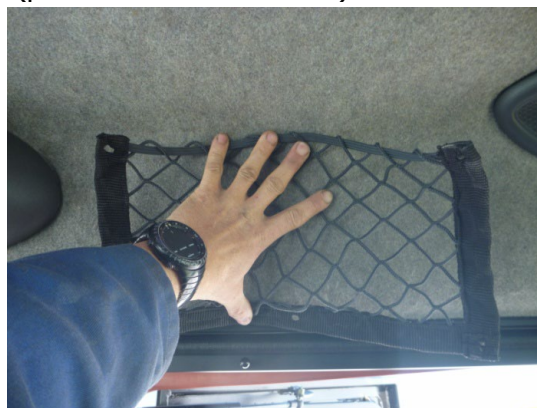
4) Retainer net

Fit an additional retainer net (part number: 513547D1) inside the cabin over the door.

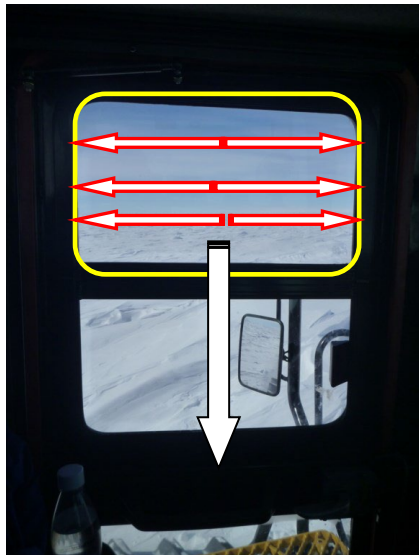
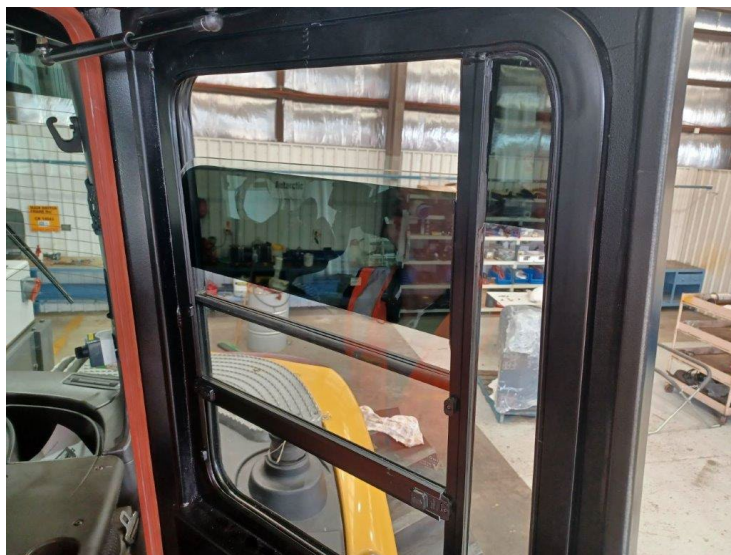
#### 5) Door windows opening

The sliding windows have to be modified because:

- The sliding windows should slide in the rail inside the cabin (ice outside can block the movement)
- We should be able to lock window in 3 different positions

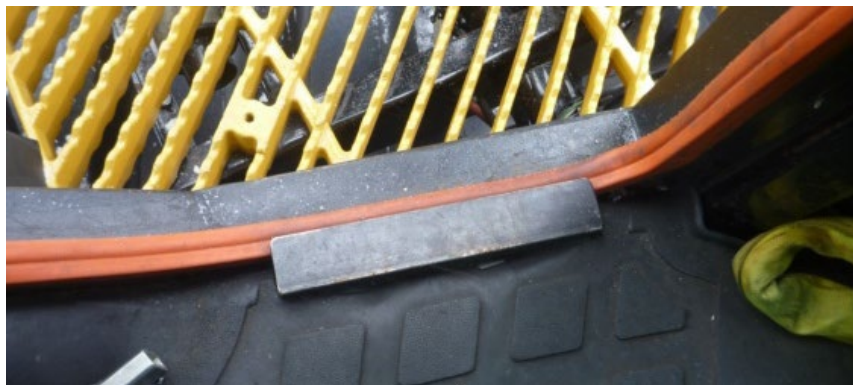
#### 6) Silicon door seal protection

Install a plate or something to protect the silicon door seal, like on picture. Replace seal if required.

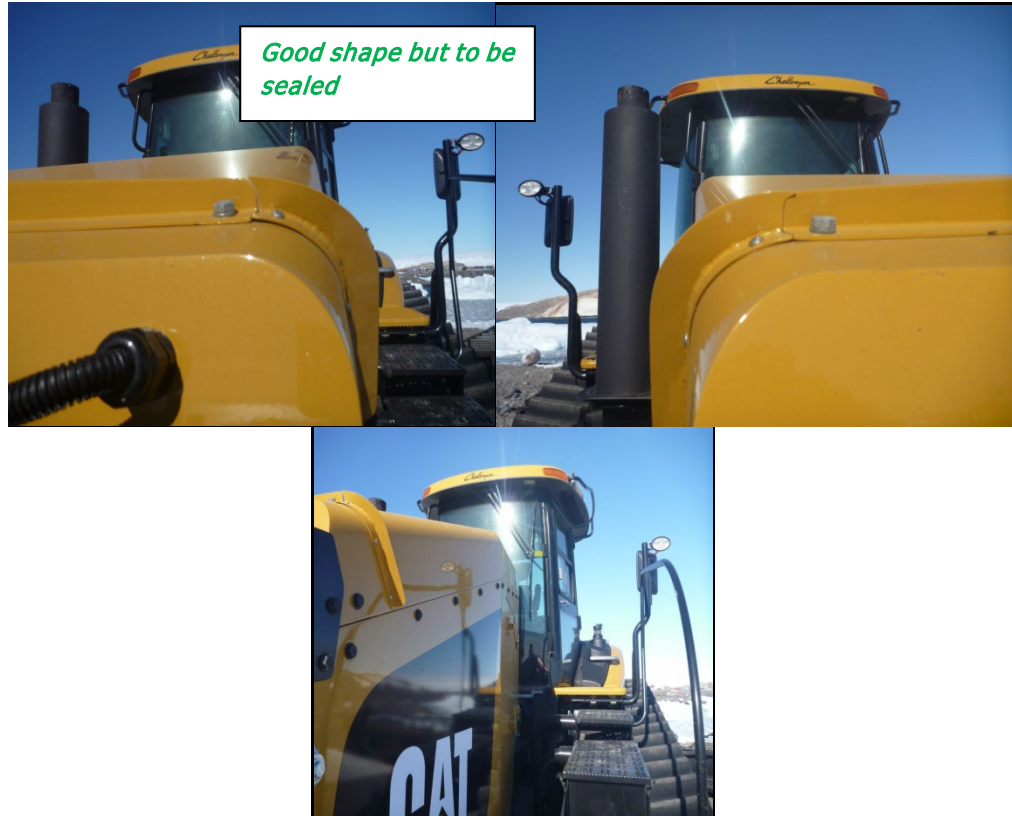
- 1) Modify water deflector. Good design alike the one on pictures below, ***but it has to be well sealed*** with the bonnet otherwise it doesn't work.

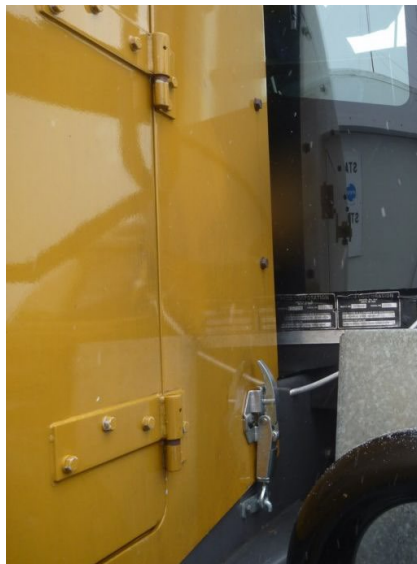
## 2) Bonnet quick handle

Remove bolt on the side to maintain bonnet, and install quick handle like on picture.

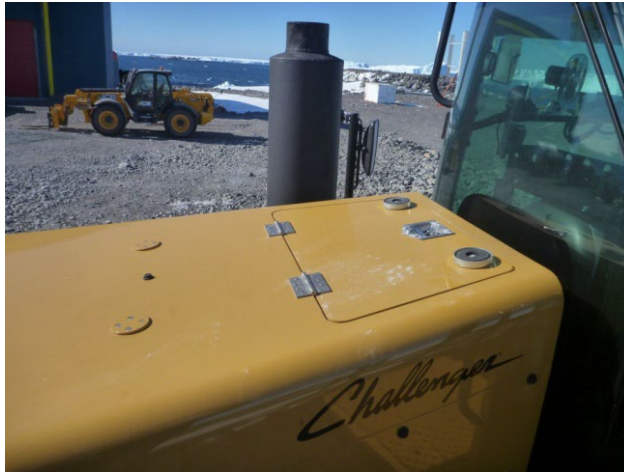
### 3) Top door

Same door and magnet locker than on the picture has to be done (see picture under)

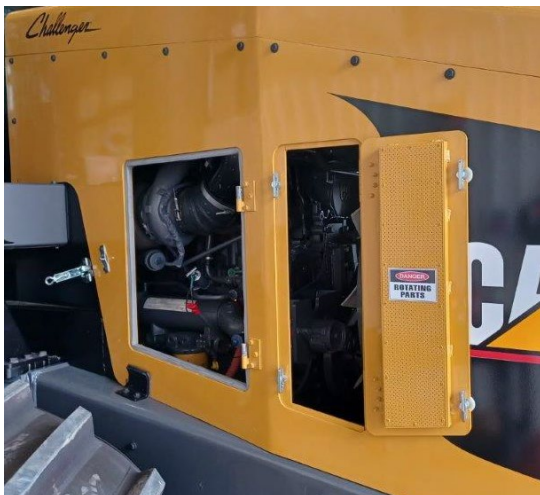
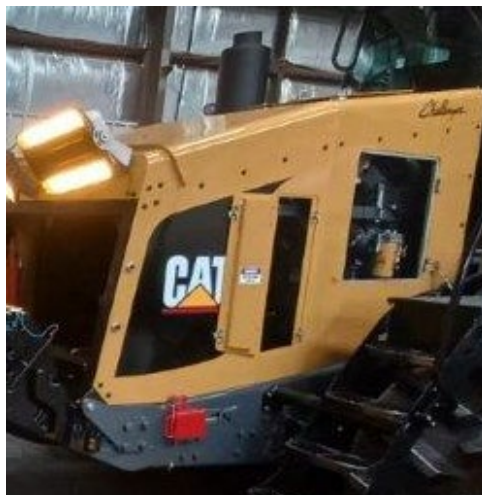
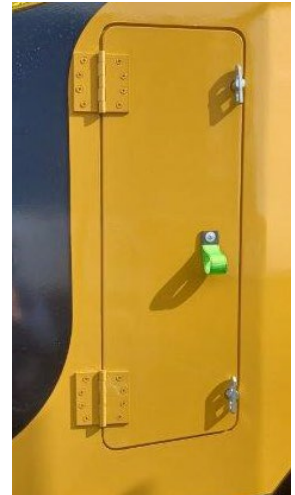
### 4) Extra side doors

Install extra side doors like on pictures.

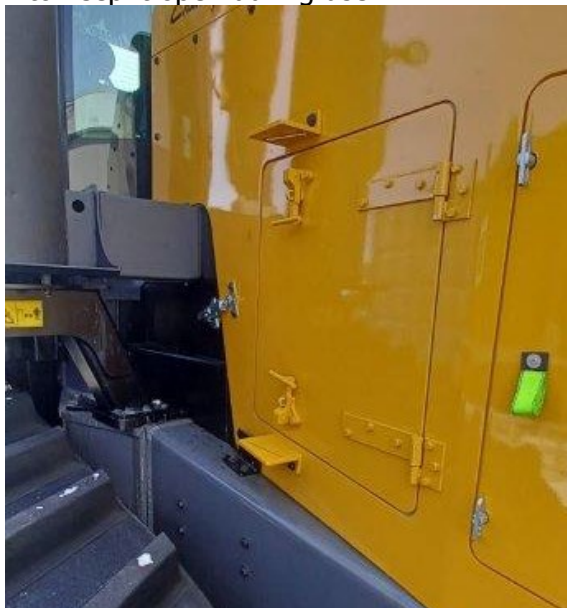
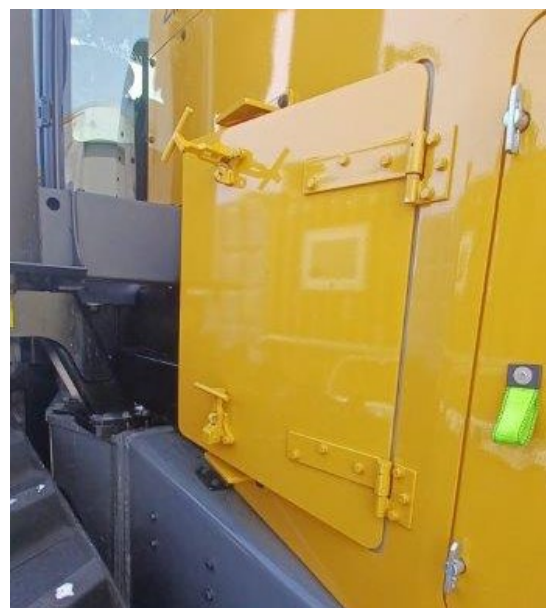
### 5) RHS door

Fit system to keep it open during use.

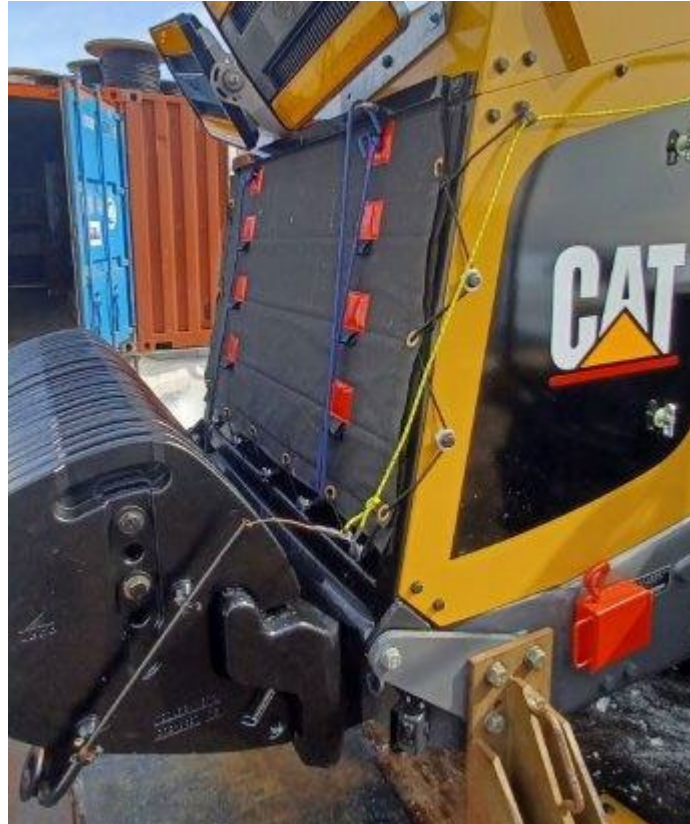
#### 6) Radiator blind

Same radiator blind than on the picture, with 2 buttons on the side of the bonnet for locking it using elastic.

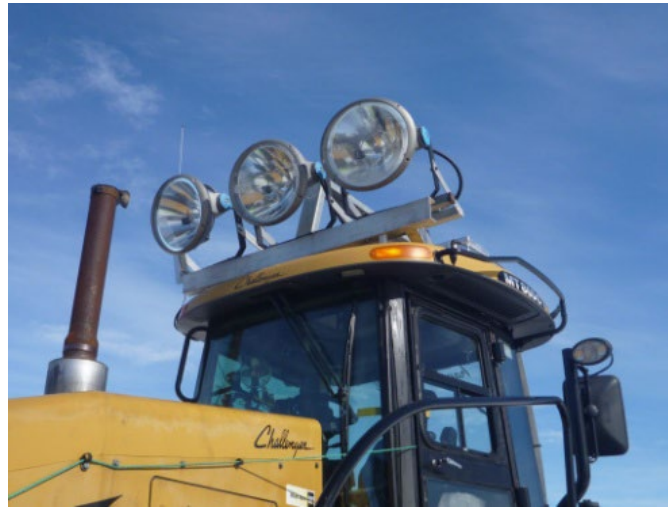
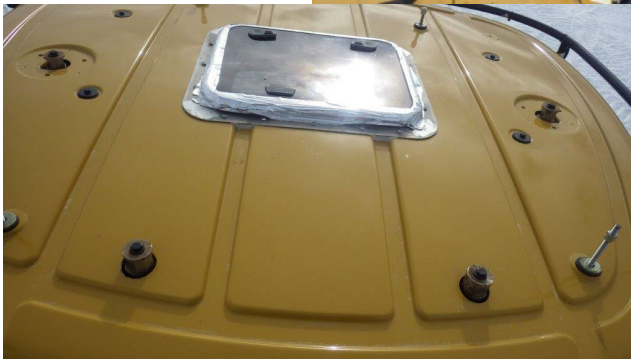
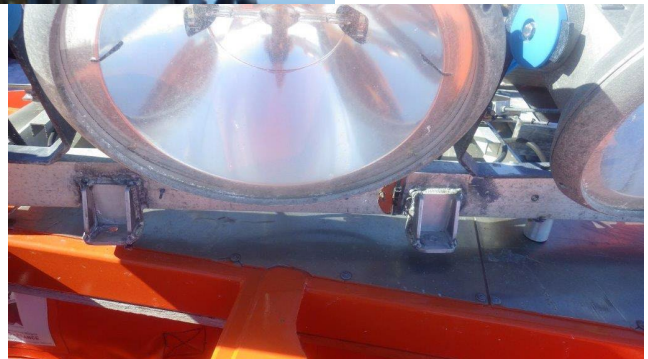
## 7) Light frame on the roof

Our light frame on the roof is around 200 kg and is maintained with only 4 bolts.

We require 4 additional bolts with spacers like on the picture. This means 4 holes have to be done in the roof cover. Aluminium chassis has to be modified like on the picture to receive additional bolts.

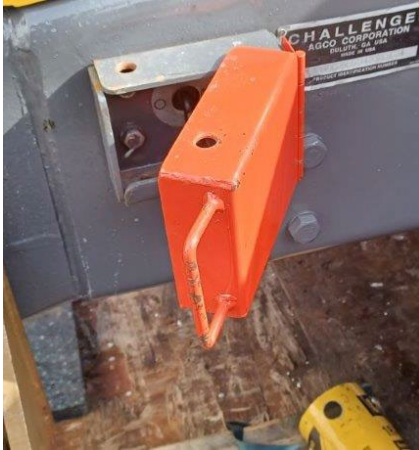
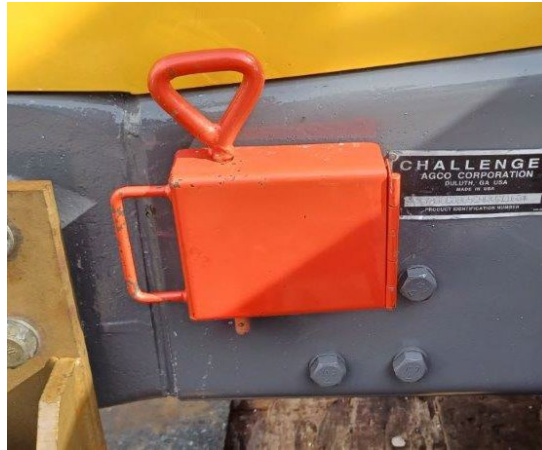
## 8) 24V main switch

Modify steel cover of main switch, as shown on pictures below

- Fit a steel hinge
- Fabricate handle
- Keep actual lock system.
- Red color painting requested
